**Engineering and Technical Consultants, Inc.**

SUBJECT: Report of Replacement Reserve Study  
Birchfield Woods Cluster Association  
Reston, Virginia  
ETC Project M4-2419

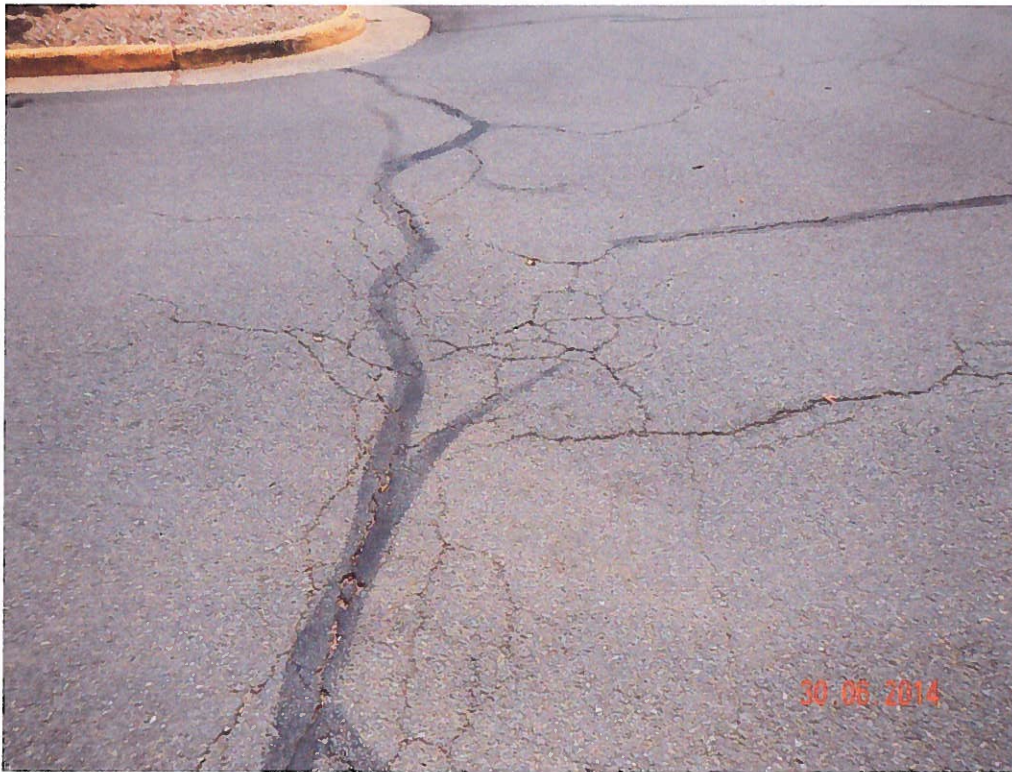
The asphalt pavement appeared at the time of our inspection to be in fair to poor condition. Simple (unconnected) cracking was noted in numerous locations areas and interconnected cracking was widespread (see Photograph 1). Interconnected cracks typically constitute broken pavement and the broken pieces will eventually dislodge, forming potholes.

Photograph 1 – Interconnected cracking in asphalt pavement.

In our opinion, the paved elements should be overlain in the within the next three (3) to five (5) years. This work could be deferred for another six (6) to eight (8) years; however, the expense to do so could be considerable. It should be noted that some interim repairs (such as filling potholes as they occur) could be necessary to limit potential for personal injury and vehicle damage.

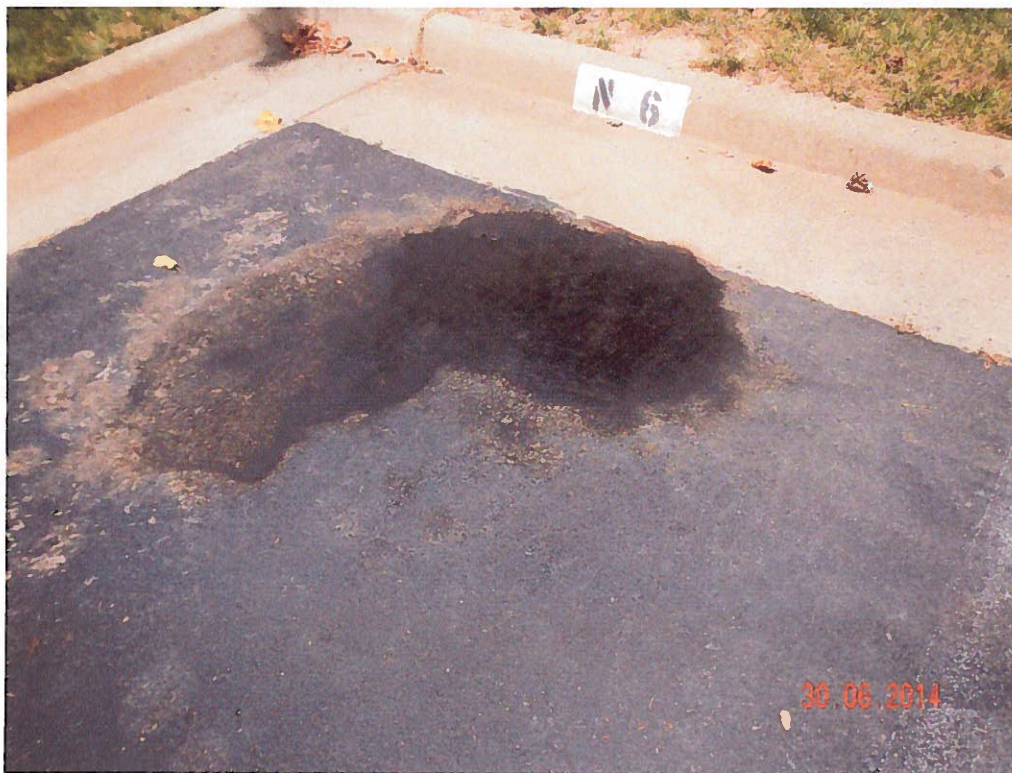
Damage from petroleum-based automotive fluids (gasoline, oil, diesel fuel, etc.) was noted in numerous locations throughout the community (see Photograph 2). Asphalt is a byproduct of crude oil refinement and vulnerable to attack by other petroleum products.

Photograph 2 – Automotive fluid on asphalt pavement.

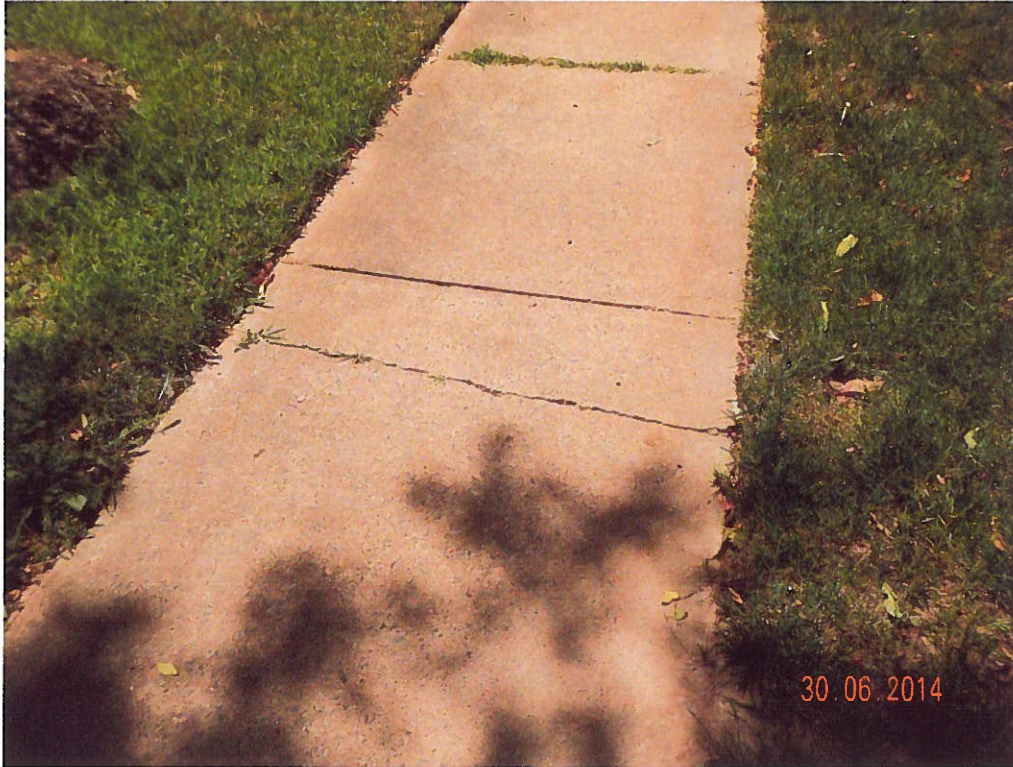
The concrete sidewalks appeared overall to be in reasonably good condition. Cracked and chipped concrete was observed in a number of locations throughout the property (see Photograph 3). Sections of concrete sidewalk were also displaced (sunken or heaved) and some of those conditions present potential tripping hazards.

Photograph 3 - Crack in concrete sidewalk.

Correction of the most obvious (and potentially hazardous) conditions should be deemed imperative. Cracks, settlement, or other defects that result in a height disparity of one-half (1/2) inch or more present potential tripping hazards. These conditions indicate serious damage that should be properly repaired. Surface treatments, patching, and other expedient methods are not recommended, as they generally prove ineffective in the long term. Therefore, total replacement of damaged concrete sections should be undertaken.

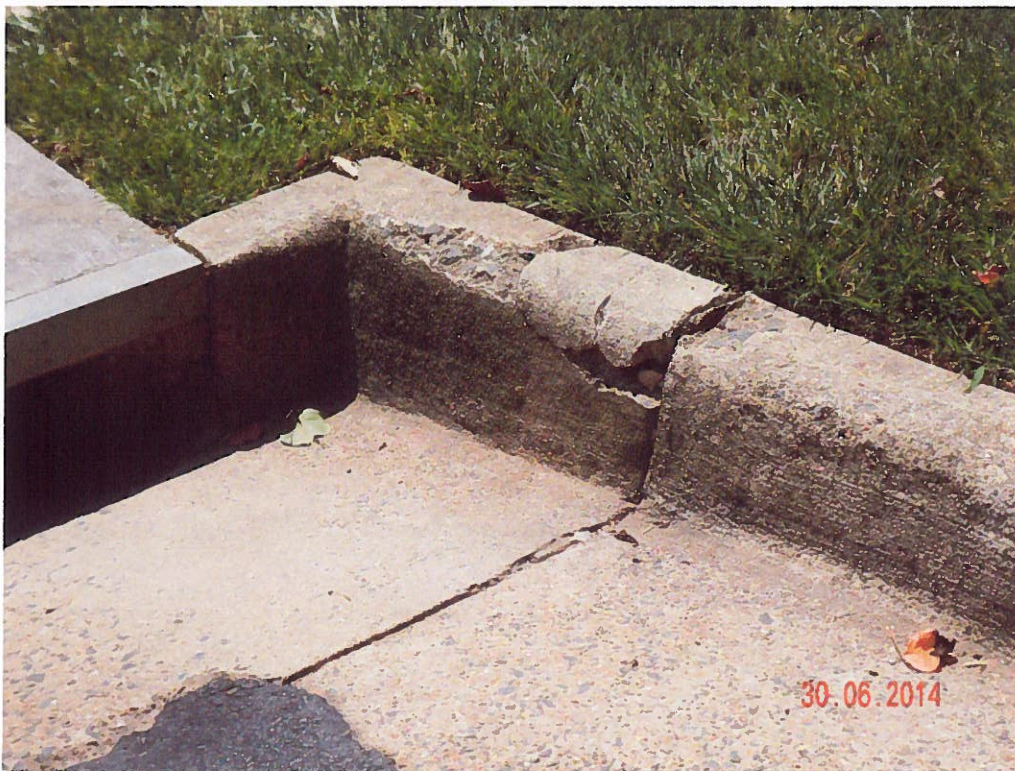
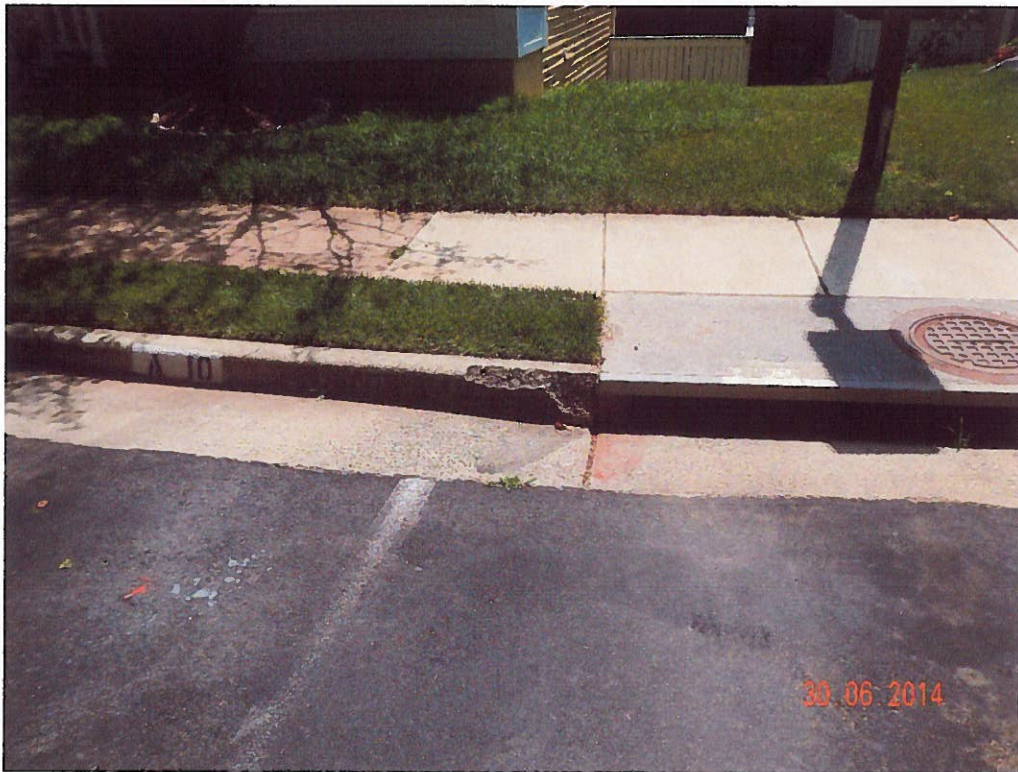
The concrete curb and gutter assemblies appeared overall to be in relatively good condition. Broken concrete was noted in areas (see Photographs 4 and 5). At least some of that damage could have been inflicted by snow plowing operations.

Photograph 4 - Broken curb and gutter assembly.

Photograph 5 – Broken curb and gutter assembly.

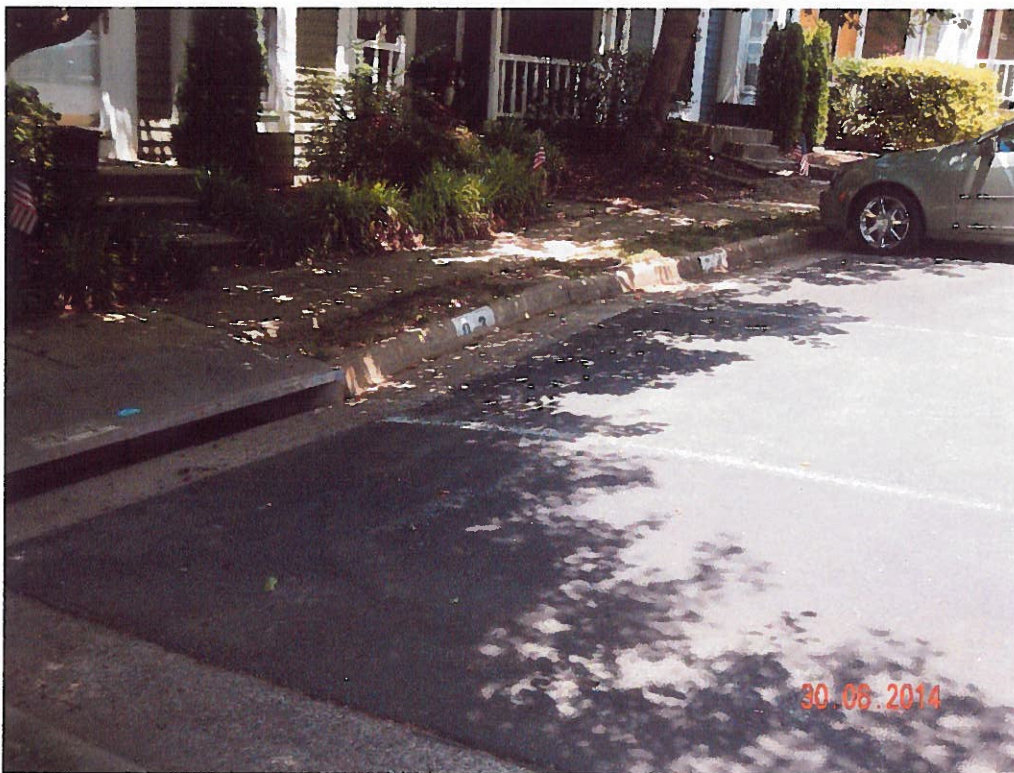
The curb and gutter assembly and nearby pavement was settled at one location (between Units 1618 and 1622) that corresponds to a storm water inlet (see Photograph 6). That displacement could be due to sub-surface erosion through defects in the storm water collection vault.

Photograph 6 – Sunken pavement and curb and gutter at storm water inlet.

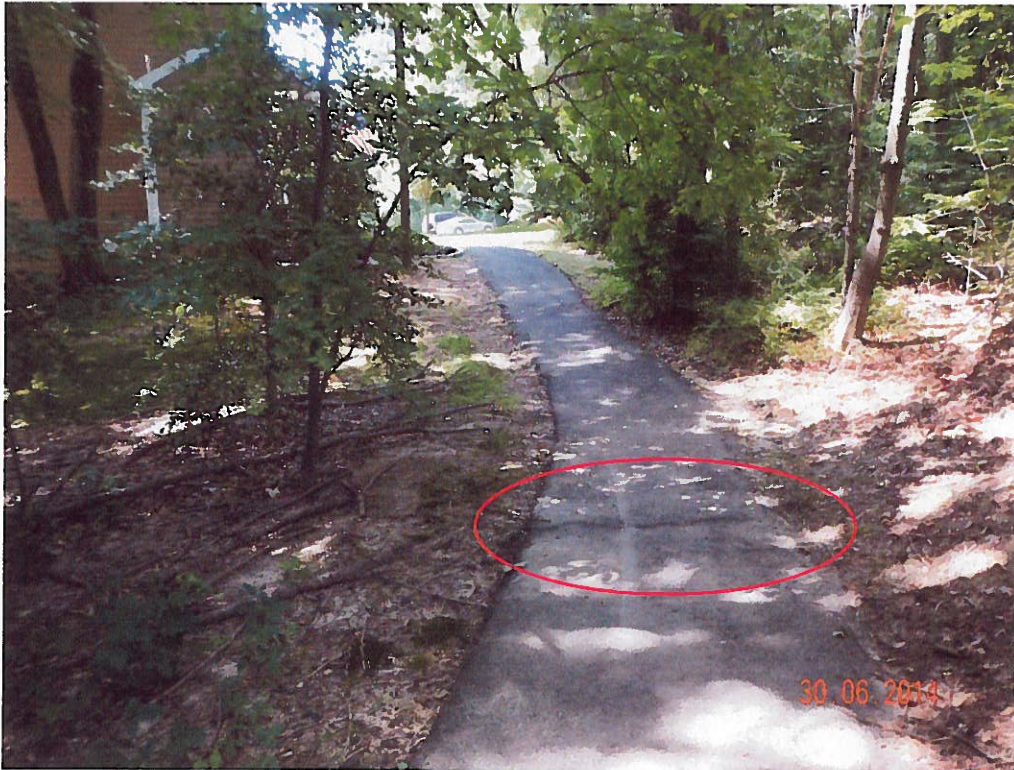
The asphalt foot paths were in fair condition overall. Some sections were uplifted by tree roots, creating potential tripping hazards (see Photograph 7). The asphalt was also cracked/broken in areas (see Photograph 8). Plant growth was noted in some cracks (see Photograph 9). Plant growth can exert sufficient pressure to widen cracks.

Photograph 7 – Asphalt foot path uplifted by tree root.

The foot path should be routinely inspected and repaired as needed. Of particular concern are potential tripping hazards. Where tree roots intrude beneath the path, they should be cut and root barrier should be installed. An arborist should be consulted before cutting major roots. Plants should be removed from cracks and the cracks should be sealed to discourage future growth.

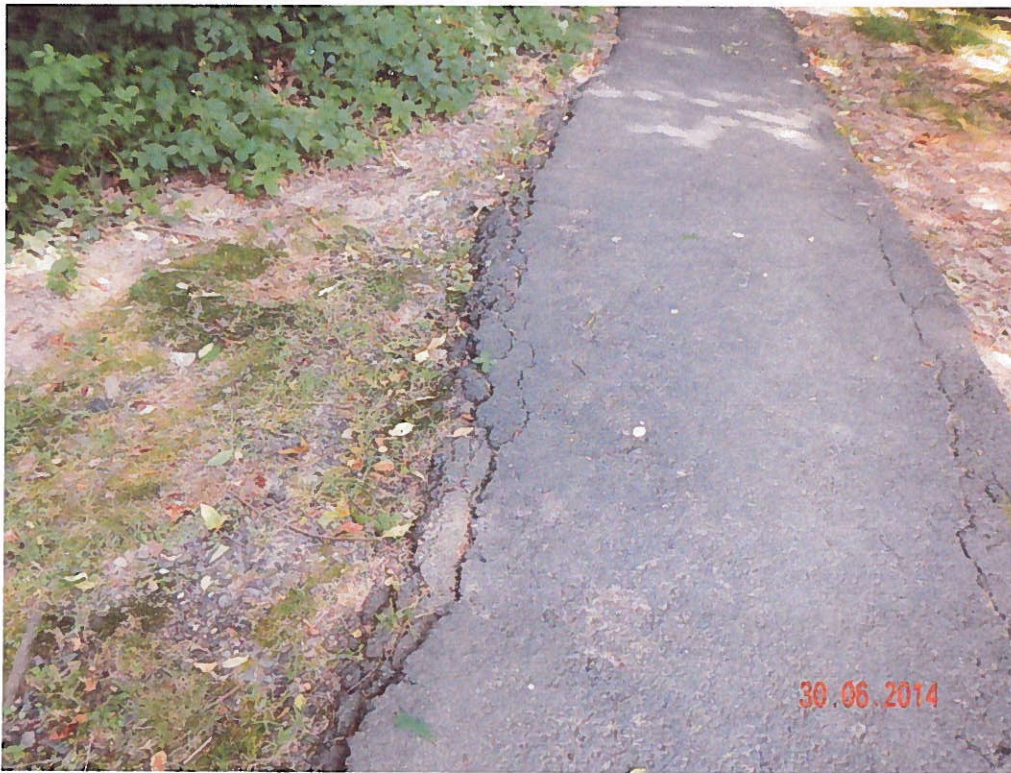
Photograph 8 – Cracked, broken asphalt foot path.

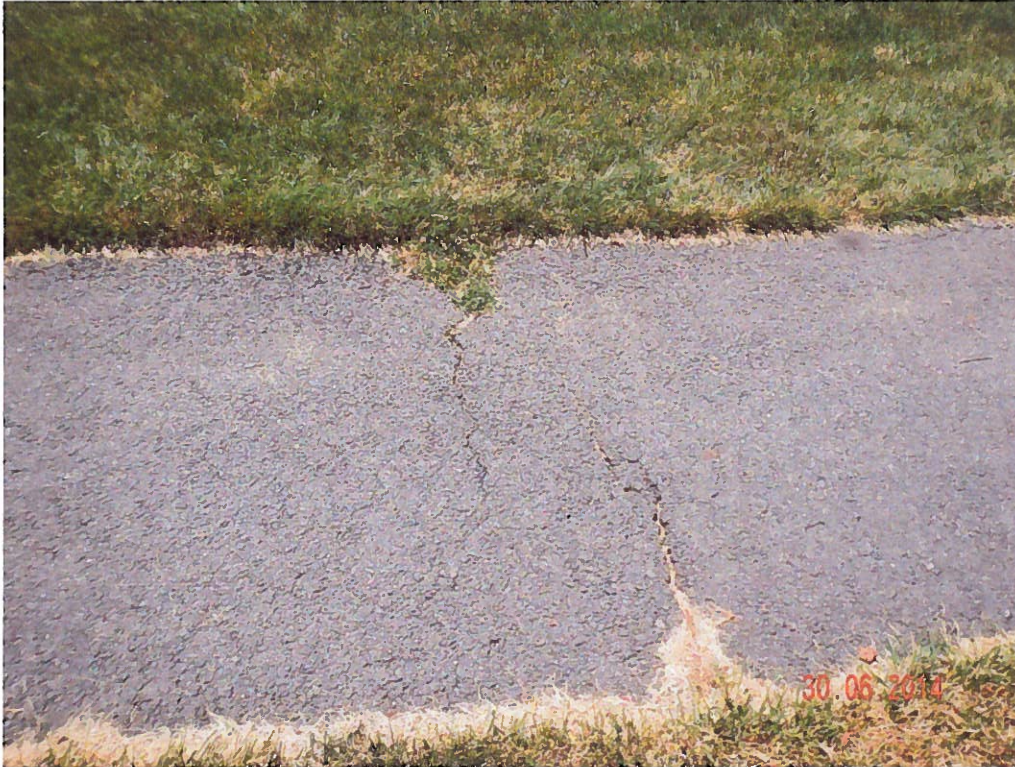
Photograph 9 – Plants in cracked asphalt foot path.

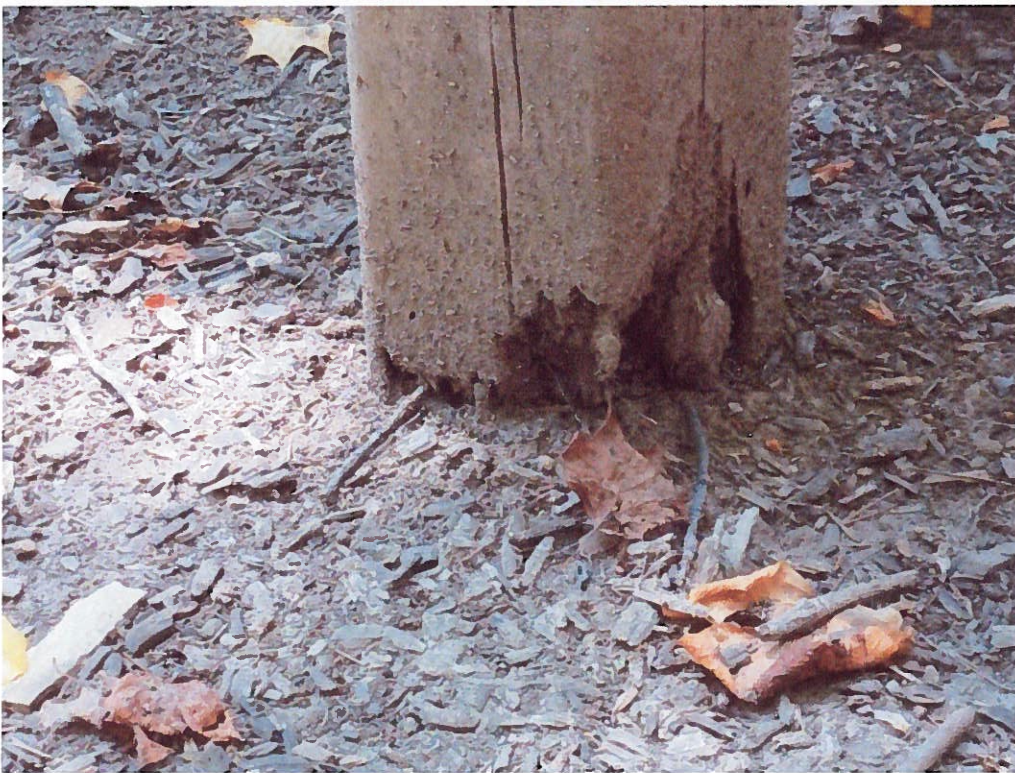
The tot-lot equipment appeared overall to be in poor condition. A number of timbers exhibited decay (see Photograph 10) and some timbers were splintered. The equipment was also aged and lacking in certain safety features found in newer equipment.

Photograph 10 – Decayed equipment support timber at tot-lot.

The tot-lot equipment should be removed and replaced at the earliest opportunity. The new equipment should be periodically inspected and maintained. Presented in Appendix C are some general inspection and maintenance guidelines. Additional information can be obtained from the Consumer Products Safety Commission.

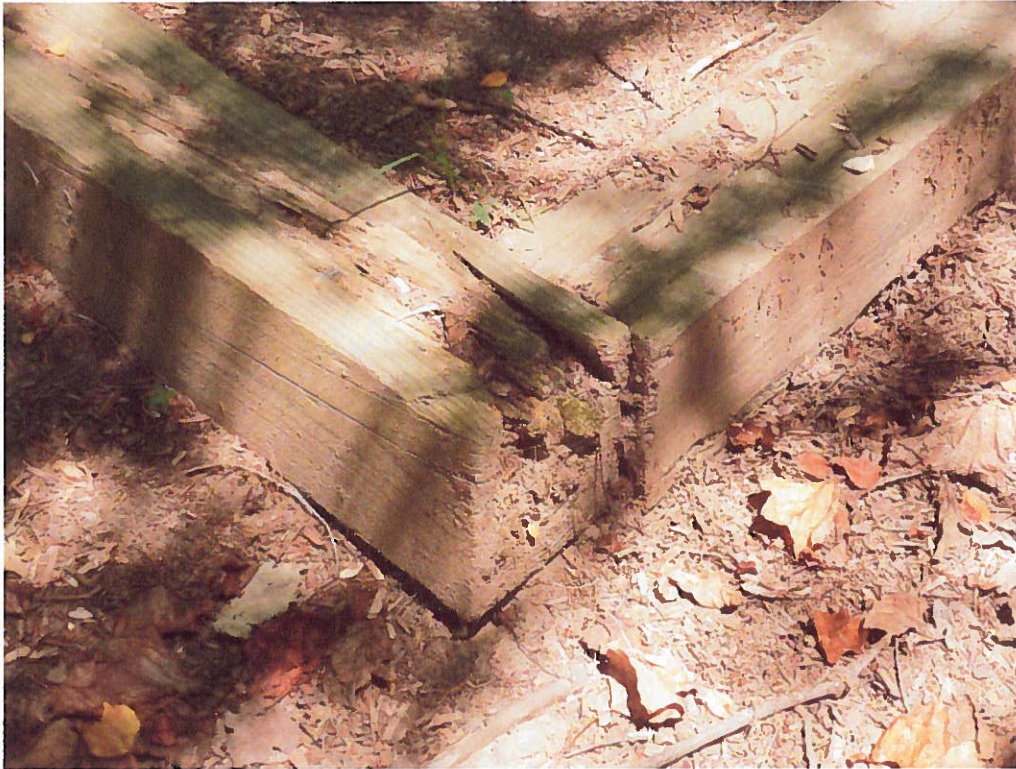
The landscaping timbers enclosing the tot-lot were in poor condition. Advanced decay was noted on most (see Photograph 11) and some sections were displaced (uplifted) by tree roots (see Photograph 12).

Photograph 11 – Decayed landscaping timber at tot-lot.

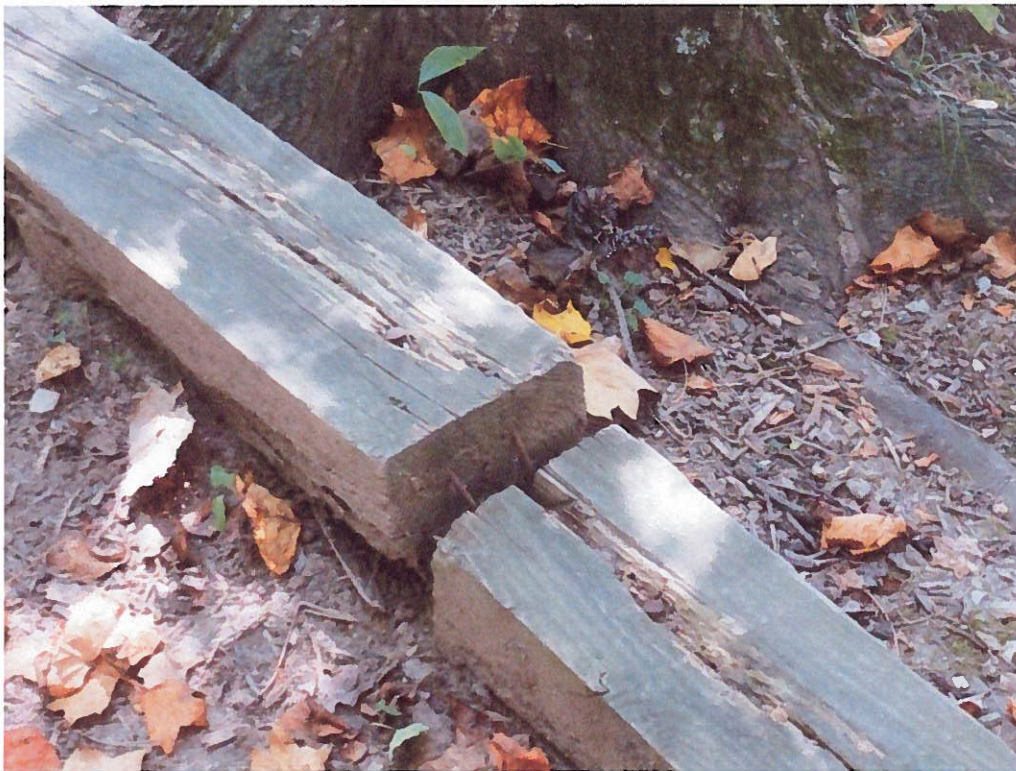
Photograph 12 – Uplifted landscaping timber at tot-lot.

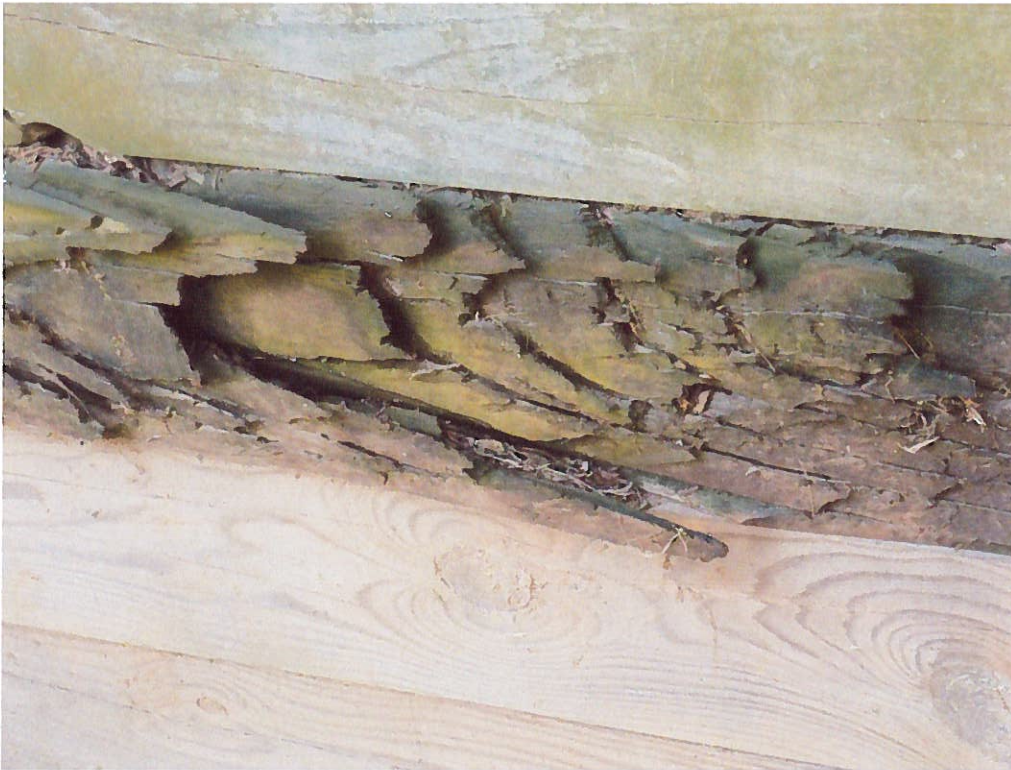
The visible elements of the older retaining walls were in fair condition. Severe checking and splintering were noted in areas (see Photograph 13). Some minor rotation (deviation from plumb) was also observed. The newer walls appeared to be in reasonably good condition.

Photograph 13 – Severely checked/splintered retaining wall timber.

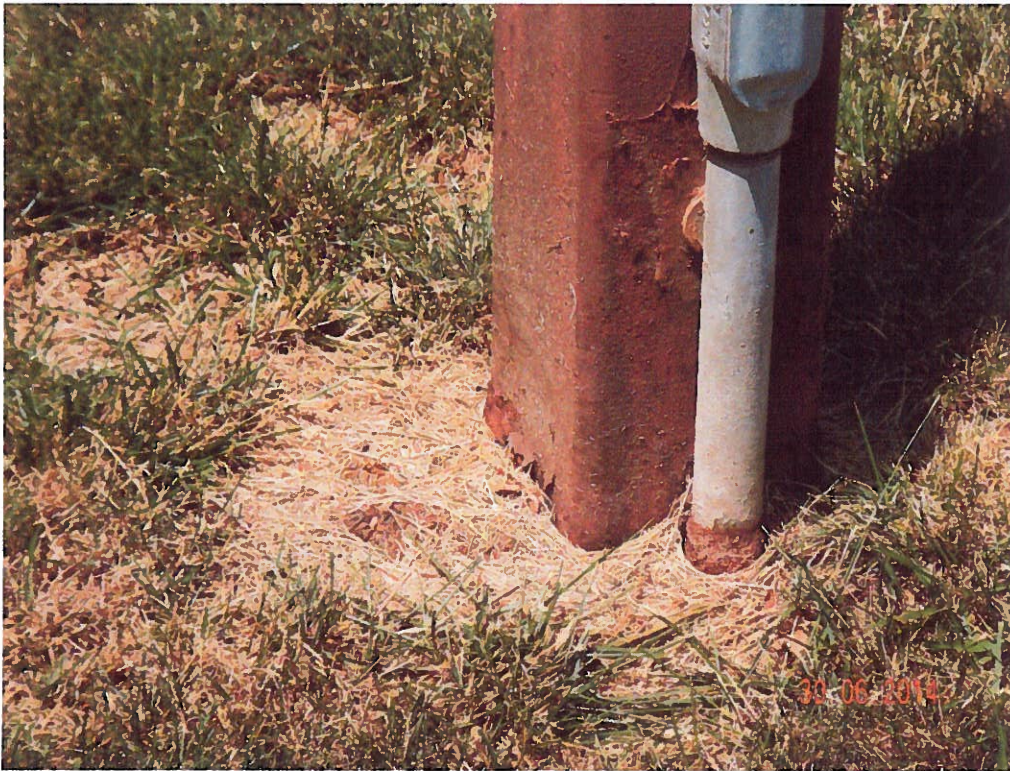
Paint coverage on the posts was poor and corrosion (rusting) of posts was widespread (see Photograph 14). Galvanized steel electrical conduits serving the lights were also corroded.

Photograph 14 – Typical rusted light post and electrical conduit.

In our opinion, the HID luminaires should probably be removed and replaced with LED fixtures. The services of a lighting engineer should be retained to better evaluate the financial benefits and design an appropriate system. The electrical conduits and conductors should probably be replaced at the same time.

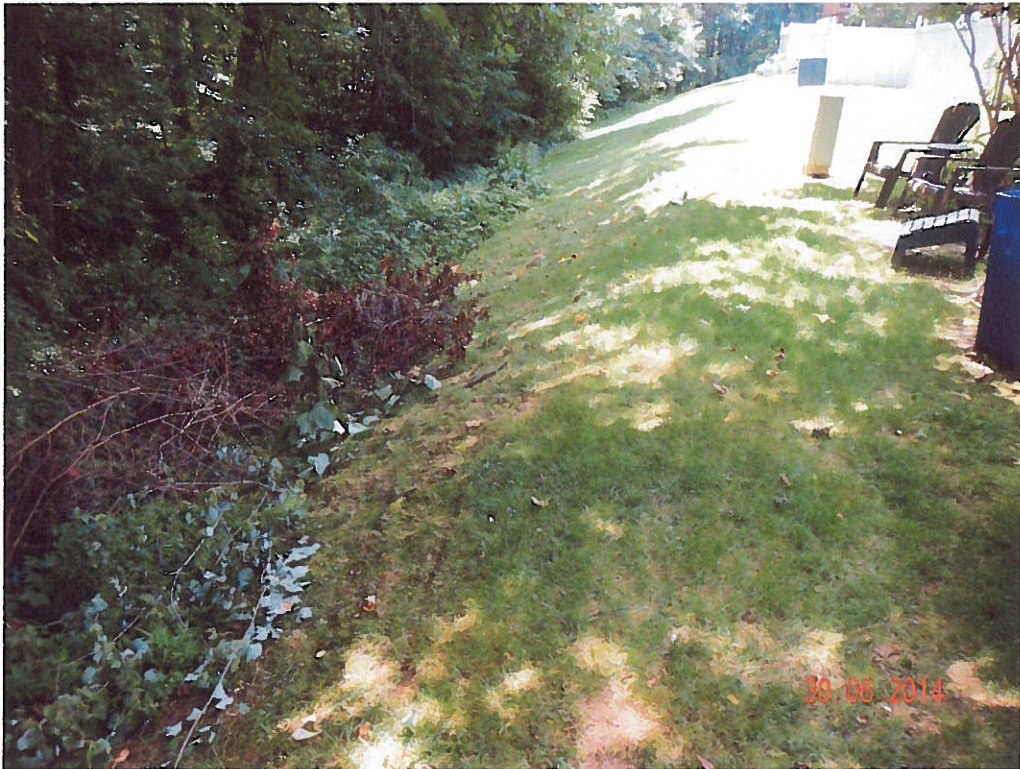
Wooded areas are located at the rears of the buildings, the terrain of which is steeply sloped (see Photograph 15). Gutter and downspout assemblies deposit storm water on grade in most areas. Swales direct storm water towards the steeply sloped areas at the rears of the buildings.

Photograph 15 – Steeply sloped terrain at the rears of the buildings.

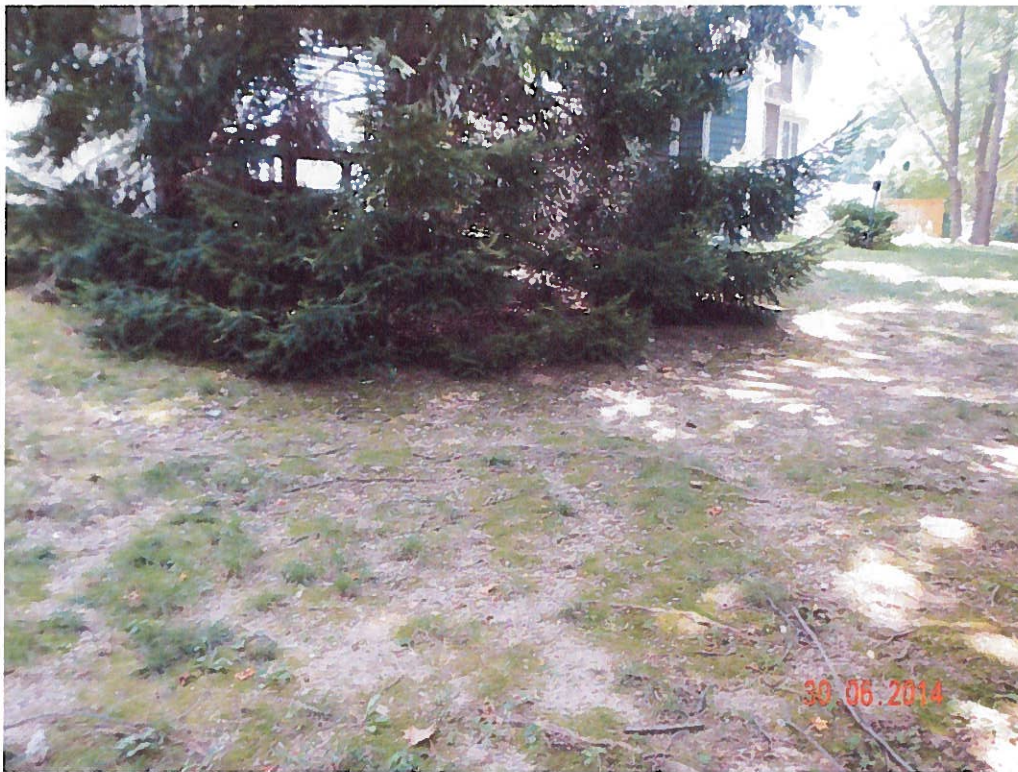
Bare areas of ground were observed in numerous locations and were typically observed in areas shaded by trees (see Photograph 16). The ground in these areas was moderately eroded and tree roots were exposed in most instances. The erosion in these areas is probably due to the lack of vegetation and the flow of storm water.

Photograph 16 – Bare areas in terrain.

Ground cover that thrives in shady conditions (such as periwinkle) should be planted in the bare areas and on the faces of the steeply sloped areas to help reduce erosion. The installation of a subsurface drainage system, of which all downspouts, condensate lines, sump pump piping, etc. are tied into would be beneficial as it would reduce the flow of storm water.
