Engineering and Technical Consultants, Inc.

June 10, 2020

SUBJECT: Report of Replacement Reserve Study
Birchfield Woods Cluster Association
Reston, Virginia
ETC Project M9-3805

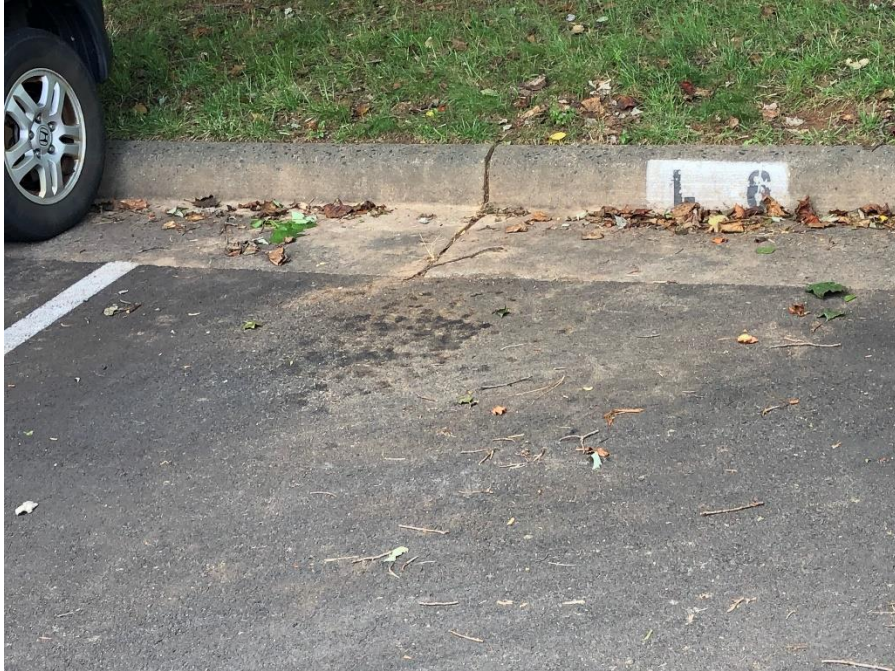
The asphalt pavement appeared to be in good condition at the time of our inspection. We understand that the pavement was milled and overlaid in 2018. Minor staining from petroleum-based automotive fluids (gasoline, oil, diesel fuel, etc.) was noted in a few locations throughout the community (see Photograph 1). Asphalt is a byproduct of crude oil refinement and vulnerable to attack by other petroleum products.

Photograph 1 – Stainng on pavement from automotive fluid

In order for the new pavement to achieve maximum life-cycle performance, it must be properly maintained and periodically seal coated, including restriping. The seal coat application will help in preventing continued automotive fluid contamination. Presented in Appendix D are some guidelines for maintaining pavement.

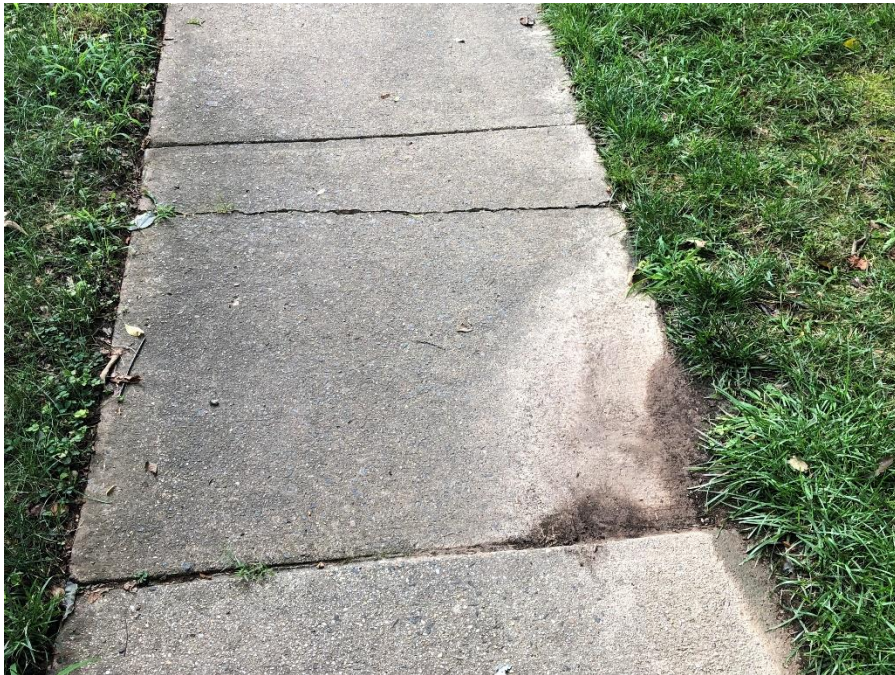
The concrete sidewalks appeared overall to be in reasonably good condition. Cracked and chipped concrete was observed in a few locations throughout the property (see Photograph 2). Sections of concrete sidewalk were also displaced (sunken or heaved), and some of those conditions present potential tripping hazards (see Photograph 3). The grassy area between the sidewalk and curb and gutter assembly was sunken in one location, and the sidewalk appeared to be undermined (see Photograph 4).

Photograph 2 – Crack in sidewalk

Correction of the most obvious (and potentially hazardous) conditions should be deemed imperative. Cracks, settlement, or other defects that result in a height disparity of one-half (1/2) inch or more present potential tripping hazards. These conditions indicate serious damage that should be properly repaired. Surface treatments, patching, and other expedient methods are not recommended, as they generally prove ineffective in the long term. Therefore, total replacement of damaged concrete sections should be undertaken.

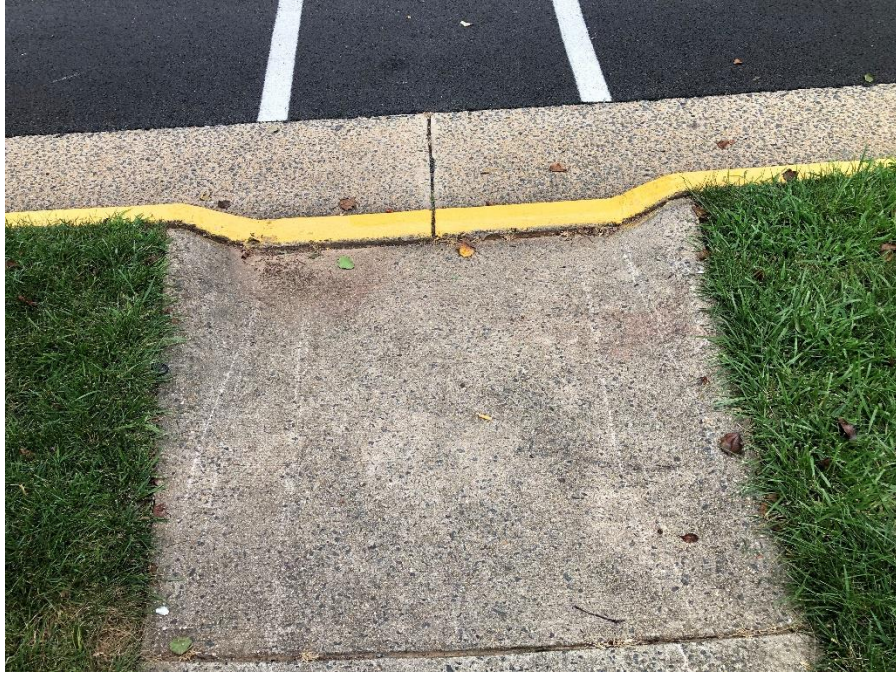
Photograph 3 – Sunken section of sidewalk

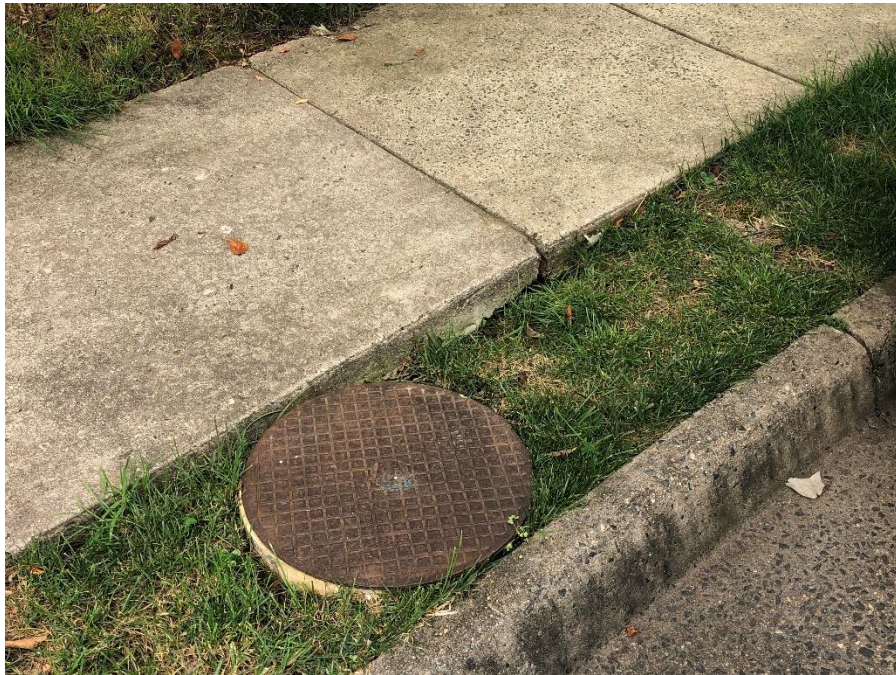
Photograph 4 – Sunken ground between sidewalk and curb – note sidewalk undermined

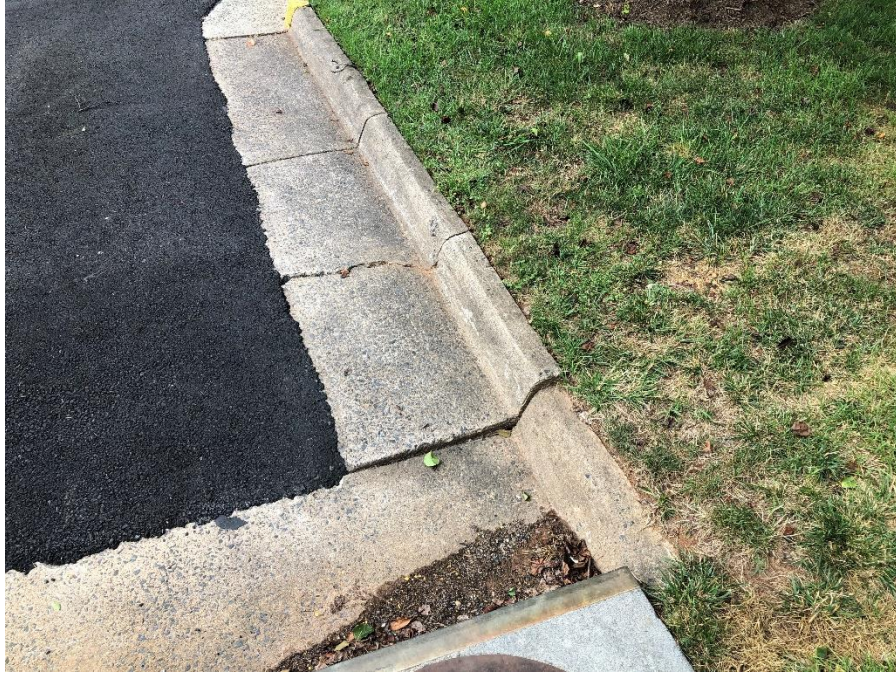
The concrete curb and gutter assemblies appeared overall to be in relatively good condition. Broken concrete was noted in areas (see Photographs 5 and 6). At least some of that damage could have been inflicted by snow plowing operations.

Photograph 5 – Cracked section of curb and gutter assembly

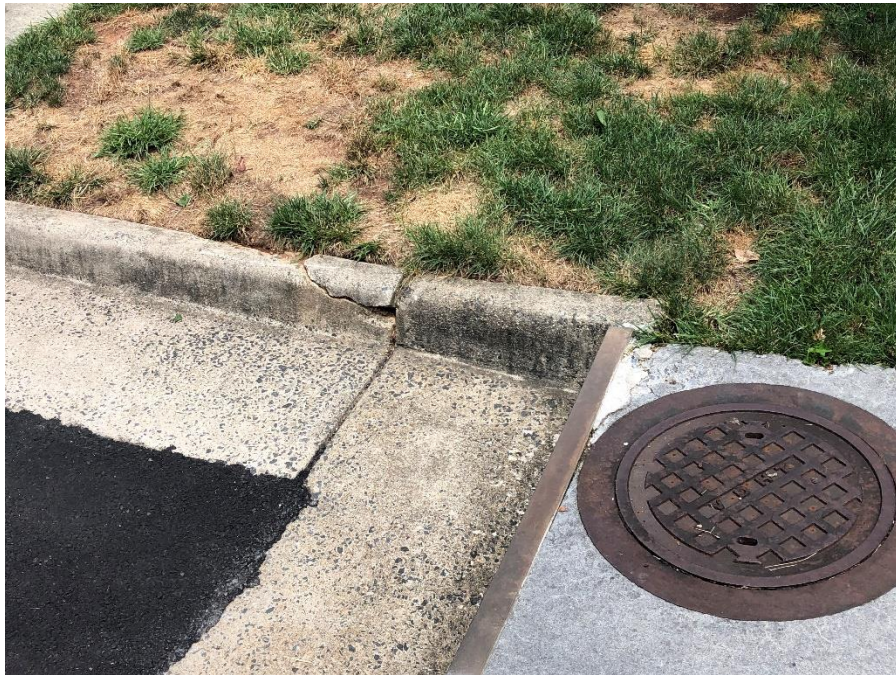
Photograph 6 – Broken section of curb and gutter assembly

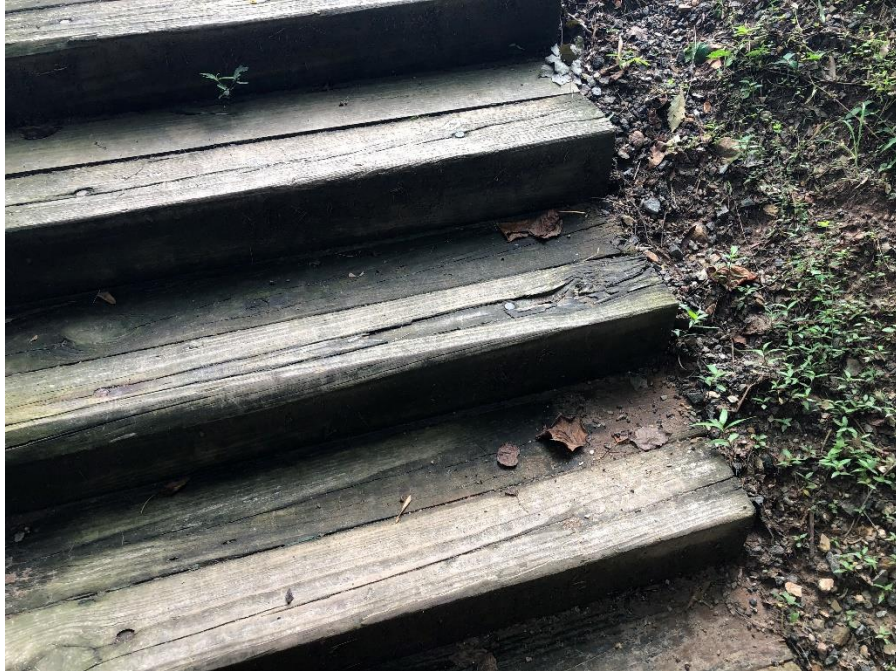
The timber stair assembly and bridge appeared to be in fair and good conditions, respectively. Some deterioration was noted in the stair assembly timbers (see Photograph 7).

Photograph 7 – Deteriorated timber in stair assembly

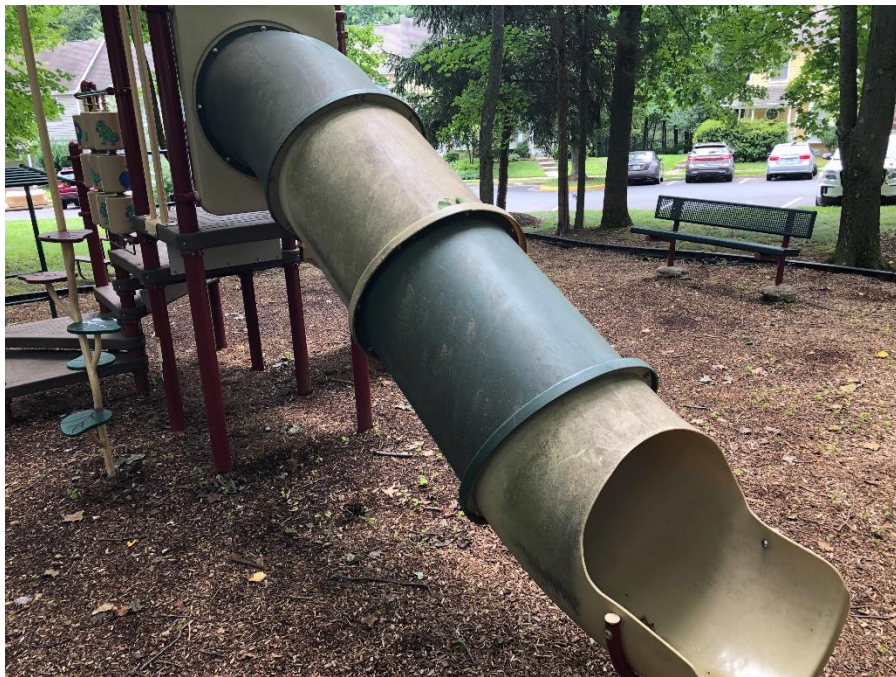
The tot-lot equipment appeared to be in good condition at the time of our inspection. Staining from pollution was evident on the tunnel slide (see Photograph 8). Additionally, the concrete footings for the bench were exposed and presented a safety hazard (see Photograph 9).

Photograph 8 – Pollution staining on slide

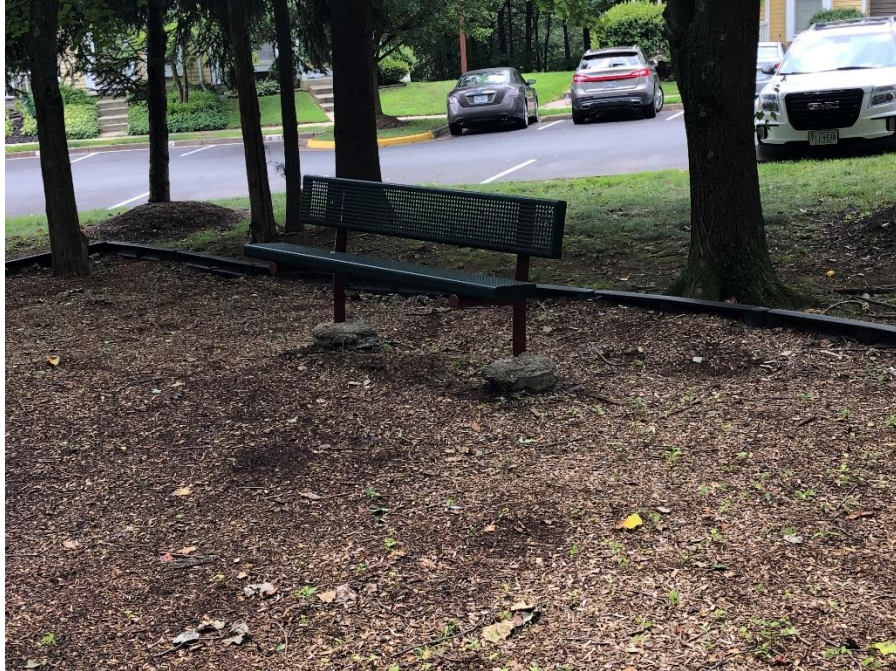
Photograph 9 – Exposed bench concret footings presenting safety hazard

Padding or additional mulch should be placed around the exposed concrete bench footings. The tot-lot equipment should be periodically inspected and maintained. Presented in Appendix C are some general inspection and maintenance guidelines. Additional information can be obtained from the Consumer Products Safety Commission.

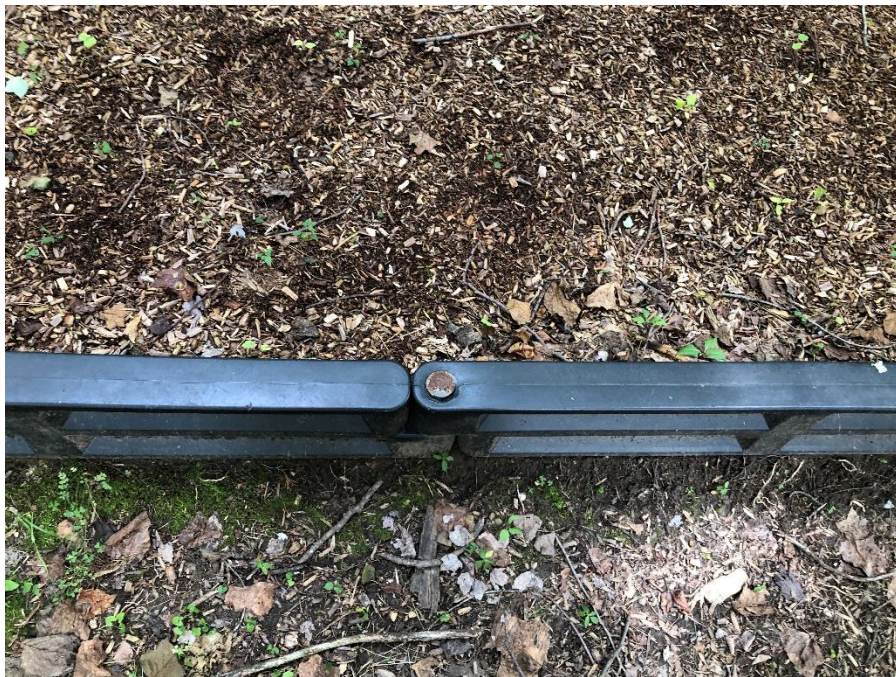
The plastic timbers enclosing the tot-lot were in good condition as well. Minor corrosion was noted on the steel spikes (see Photograph 10).

Photograph 10 – Corrosion on tot-lot border spike

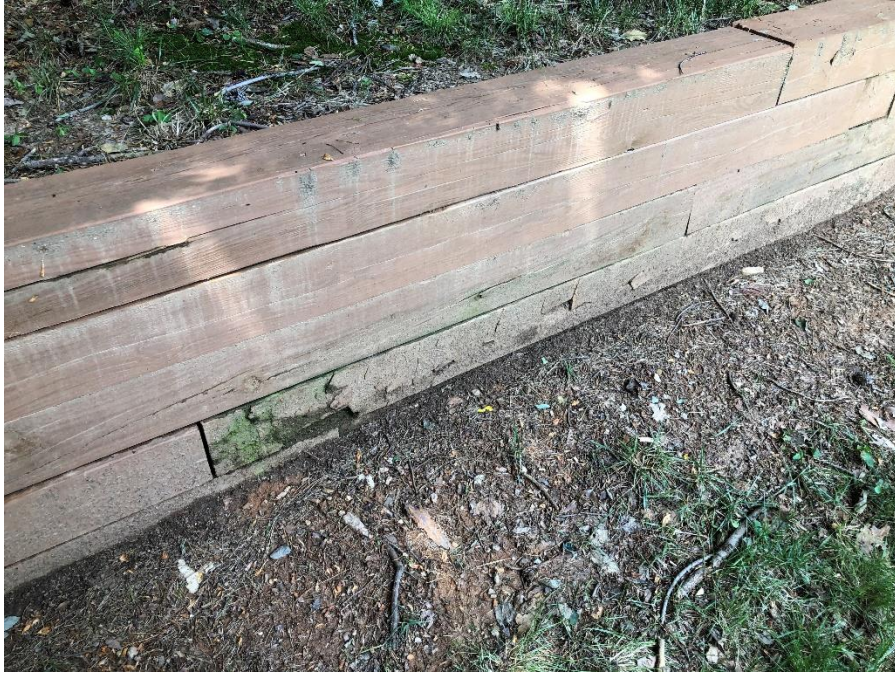
The visible elements of the retaining walls were in fair condition. Deteriorated (decayed) timbers were observed within walls in a number of areas (see Photographs 11 and 12). The deterioration typically occurred in the timbers along the top and bases of the walls. In some instances, the exposed ends of the tiebacks were deteriorated (decayed) (see Photograph 13). Tiebacks are used to support the wall from bulging under the load of the retained soil. Deterioration could compromise the connection to the wall and destabilize the wall.

Photograph 11 – Deteriorated timber along base of retaining wall

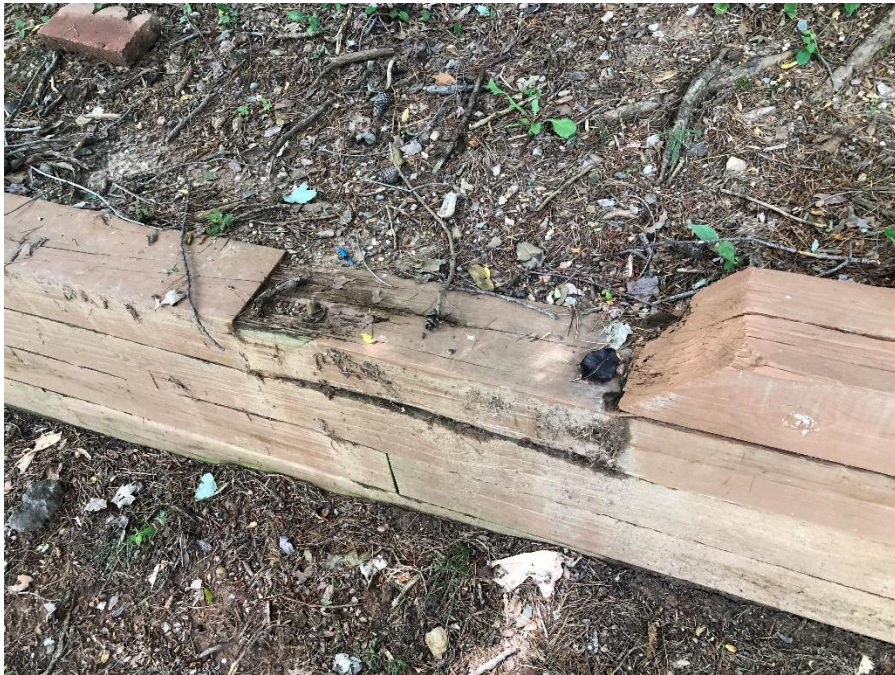
Photograph 12 – Deteriorated timber along top of retaining wall

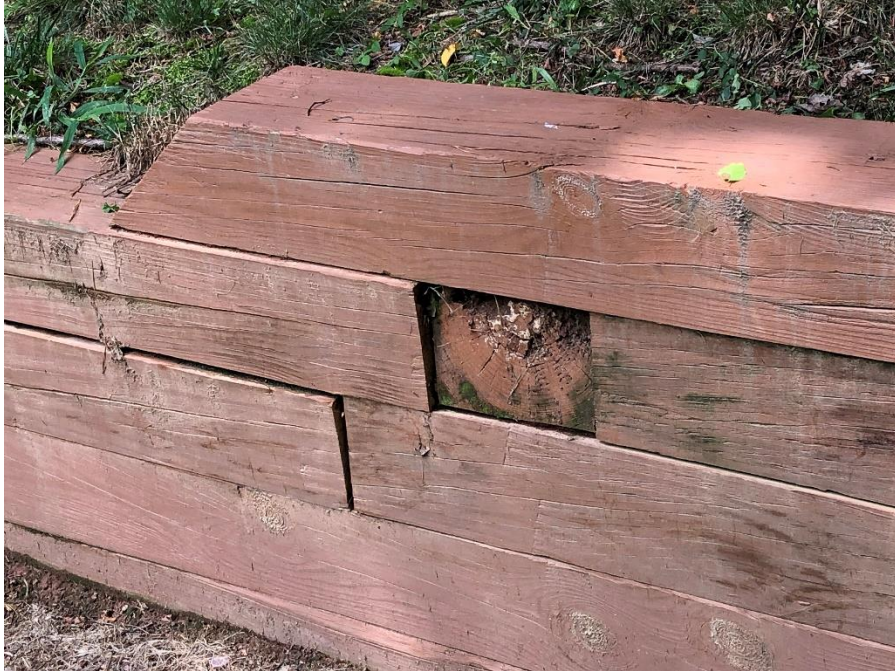
Photograph 13 – Deteriorated end of retaining wall tie-back timber

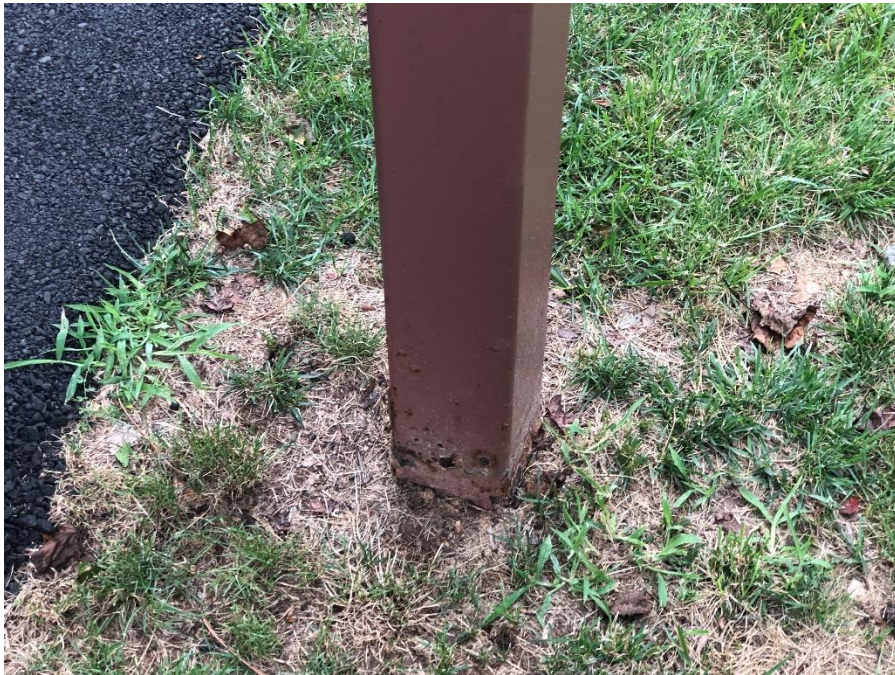
The exterior lighting provisions were inspected during non-operational (daylight) hours and we cannot comment on the operation of individual fixtures. The lighting system appeared to provide reduced illumination in areas, due in part to obstruction by leaves of nearby trees. The posts appeared to have been repainted; although, corrosion was evident at the bases of some of the posts (see Photograph 14).

Photograph 14 – Corrosion at base of light post

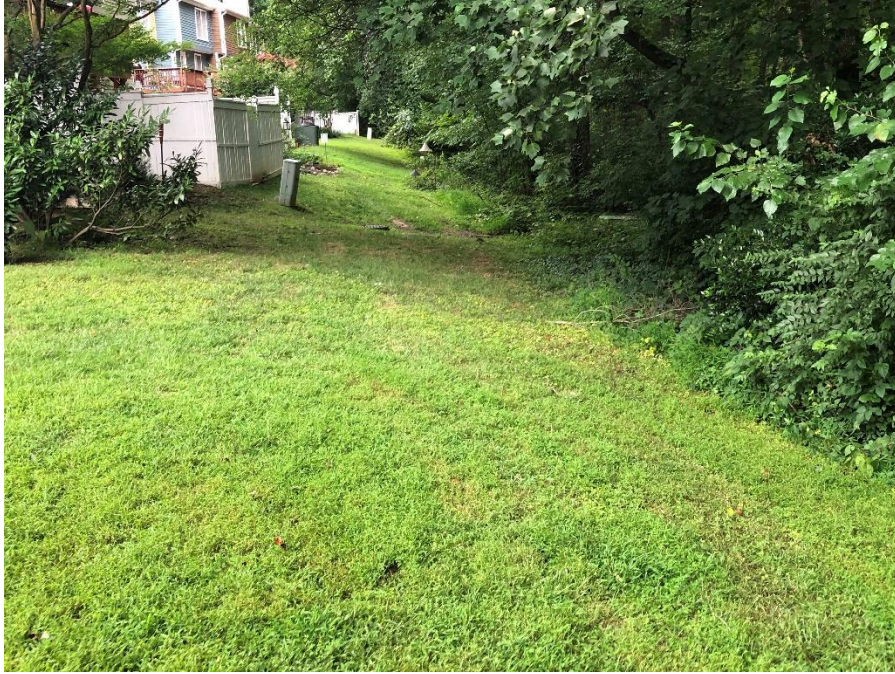
Wooded areas are located at the rears of the buildings and adjacent to the tot-lot. The terrain is steeply sloped in the grassy areas adjacent to the forested areas (see Photograph 15). Gutter and downspout assemblies deposit stormwater on grade in most areas. Swales direct stormwater towards the steeply sloped areas at the rears of the buildings.

Photograph 15 – Steep-sloped area along rear of house

A ground cover that thrives in shady conditions (such as periwinkle or pachysandra) should be planted in the bare areas and on the faces of the steeply sloped areas to help reduce erosion. The installation of a subsurface drainage system, of which all downspouts, condensate lines, sump pump piping, etc. are tied into would be beneficial as it would reduce the flow of stormwater. If erosion adjacent to the steeply sloped terrain worsens, construction of retaining walls may be required in the future. These areas should be inspected periodically to determine whether erosion is occurring.

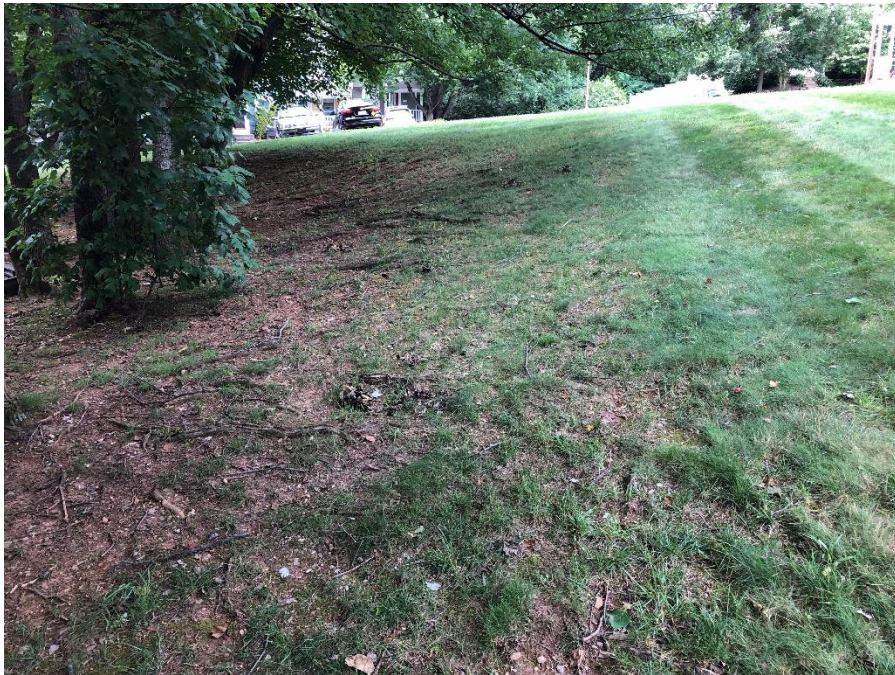
Bare areas of ground were observed in numerous locations and were typically observed in areas shaded by trees (see Photograph 16). The ground in these areas was moderately eroded and tree roots were exposed in most instances. The erosion in these areas is probably due to the lack of vegetation and the flow of stormwater.

Photograph 16 – Steep-sloped area adjacent to tot-lot – note bare areas and exposed roots
